DODIG-2015-013

OCTOBER 28, 2014

Military Housing Inspections – Republic of Korea

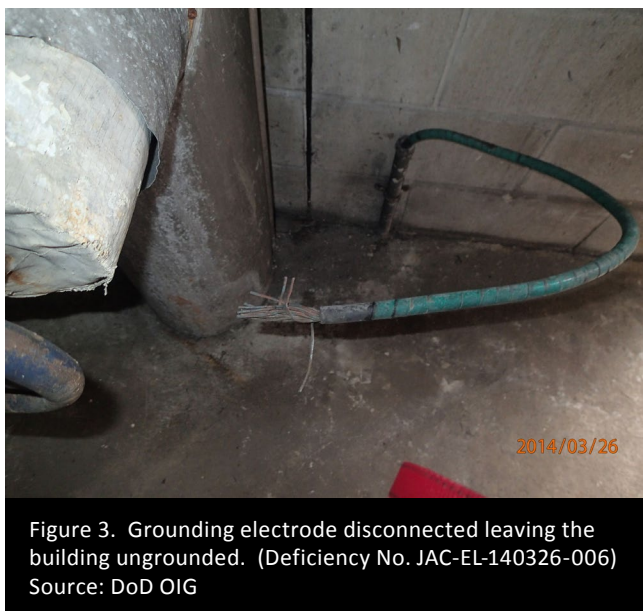
Figure 3. Grounding electrode disconnected leaving the building ungrounded. (Deficiency No. JAC-EL-140326-006)
Source: DoD OIG

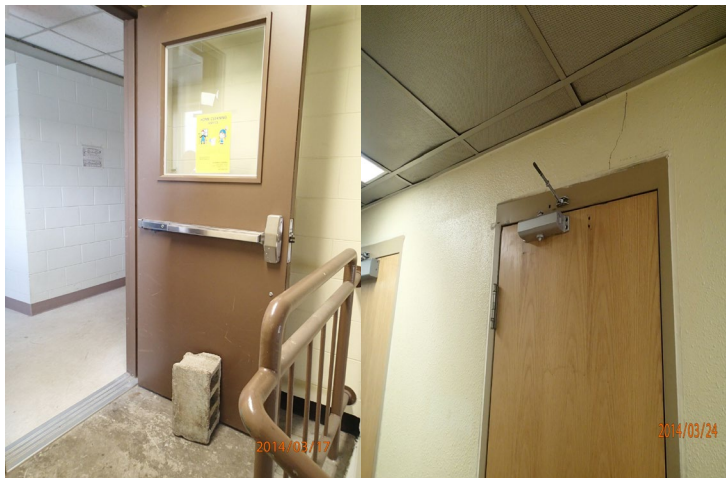
Figure 4. Ineffective use of fire doors allows fire to draft through the entire building. Left: Fire rated doors often propped open (Deficiency No. CAS-FP-140317-024) Right: Broken automatic closing mechanisms (Deficiency No. CRC-FP-140324-013) Source: DoD OIG

Fire protection deficiencies included fire doors that were propped open, did not automatically and fully close, and were not fire rated (see Figure 4). We found dryer vents that were disconnected, pinched or shredded, and constructed of improper material (see Figure 5). Also, we found multiple sprinkler systems that were out of service and without temporary life safety measures.

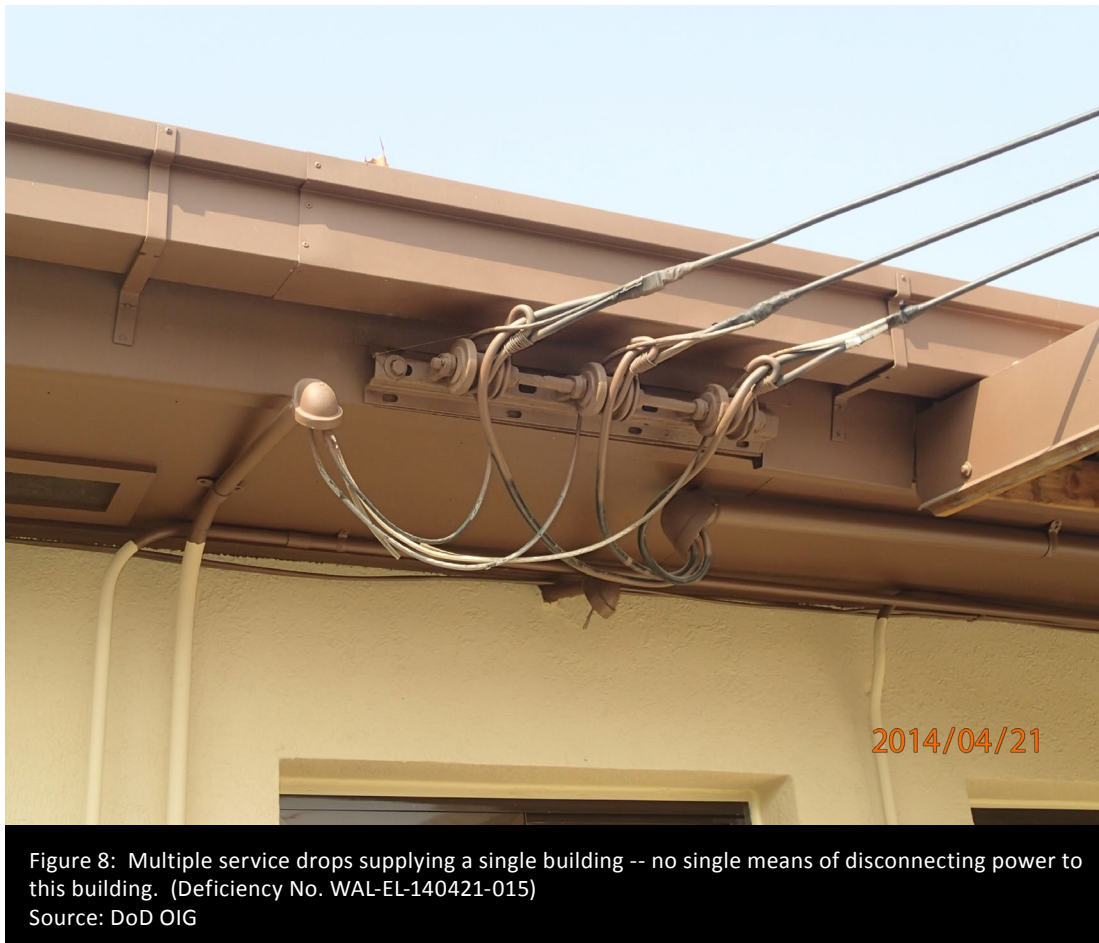
Electrical deficiencies included single buildings being supplied by multiple service drops (see Figure 8) and service drops/power lines that were too low. As at other bases, we found that water circulating pump motors were not grounded in mechanical rooms and several instances where GFCI protection was missing. We found exposed energized wiring due to missing electrical service panel breaker blanks or broken electrical covers, missing exterior light fixture covers, and missing knockout seals and covers in junction boxes. Additionally, we found several grounding issues where the first disconnecting means at the main electrical panel was not bonded. These deficiencies create electrocution hazards for installation personnel.

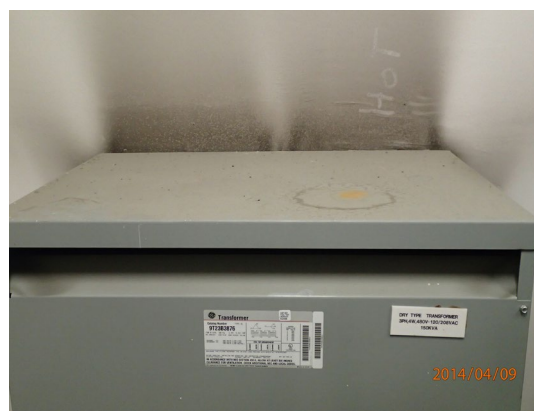
Electrical deficiencies included inadequate vent space for cooling transformers (see Figure 9), and improperly maintained or functioning temperature control equipment in mechanical and electrical rooms. As at other bases, we found broken conduits, receptacles with reversed polarity, and missing covers in junction boxes. We also identified missing GFCI protection in laundry rooms, vending machines, and water coolers. These deficiencies create electrocution hazards for installation personnel.

Figure 9. Inadequate transformer clearance from wall. Overheating can cause early equipment failure, fire, and explosion (Deficiency No. OSA-EL-140407-018)
Source: DoD OIG

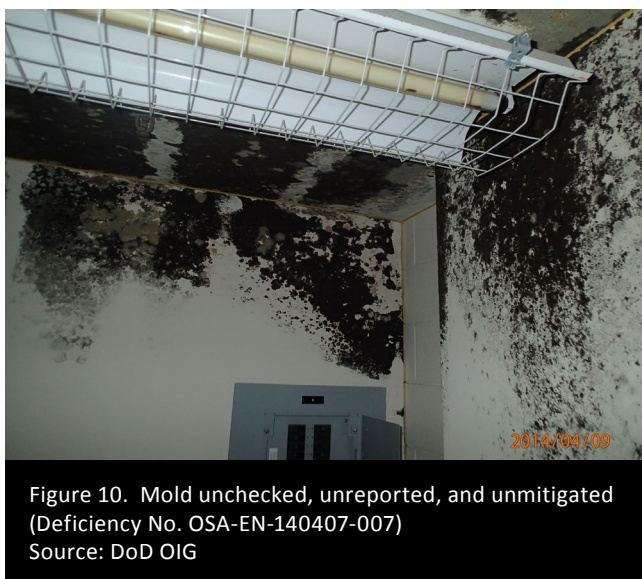
Figure 10. Mold unchecked, unreported, and unmitigated (Deficiency No. OSA-EN-140407-007)
Source: DoD OIG

evidenced by mold found in several buildings (see Figure 10). In addition, Osan Air Base did not address the radon issue at buildings that exceeded acceptable radon levels and did not develop and implement a radon mitigation program for military housing, despite EPA studies stating that radon is a carcinogen that causes thousands of deaths each year.

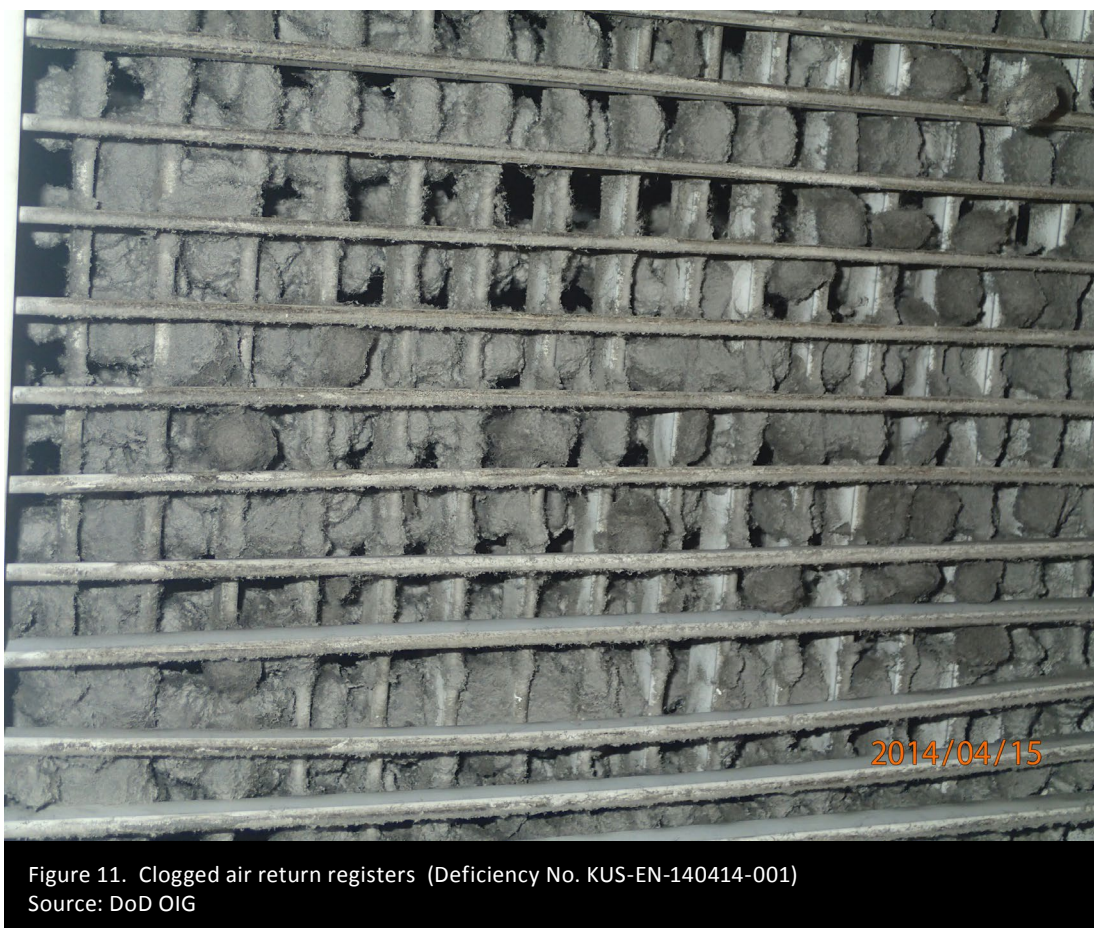
Environmental deficiencies included water damage to ceiling tiles and drywall due to poorly maintained HVAC systems and plumbing pipes. We also found that in some instances, the air handling units were not operating. We noted a lack of communication between unaccompanied housing and the civil engineering component on established roles and responsibilities. For example, there were no agreed-upon procedures for preventive maintenance of the fan coil unit filters and air registers (see Figure 11).

Figure 11. Clogged air return registers (Deficiency No. KUS-EN-140414-001)
Source: DoD OIG
